Replacement kit für AXIS Q6032-E

Using the Q 6032-E from AXIS you face the problem, that the view in horizontal position is only possible with a failure in the picture sharpness. This grounded on the original domglas from AXIS. To get a sharp picture also in horizontal camera position we offer a domglas replacement kit.

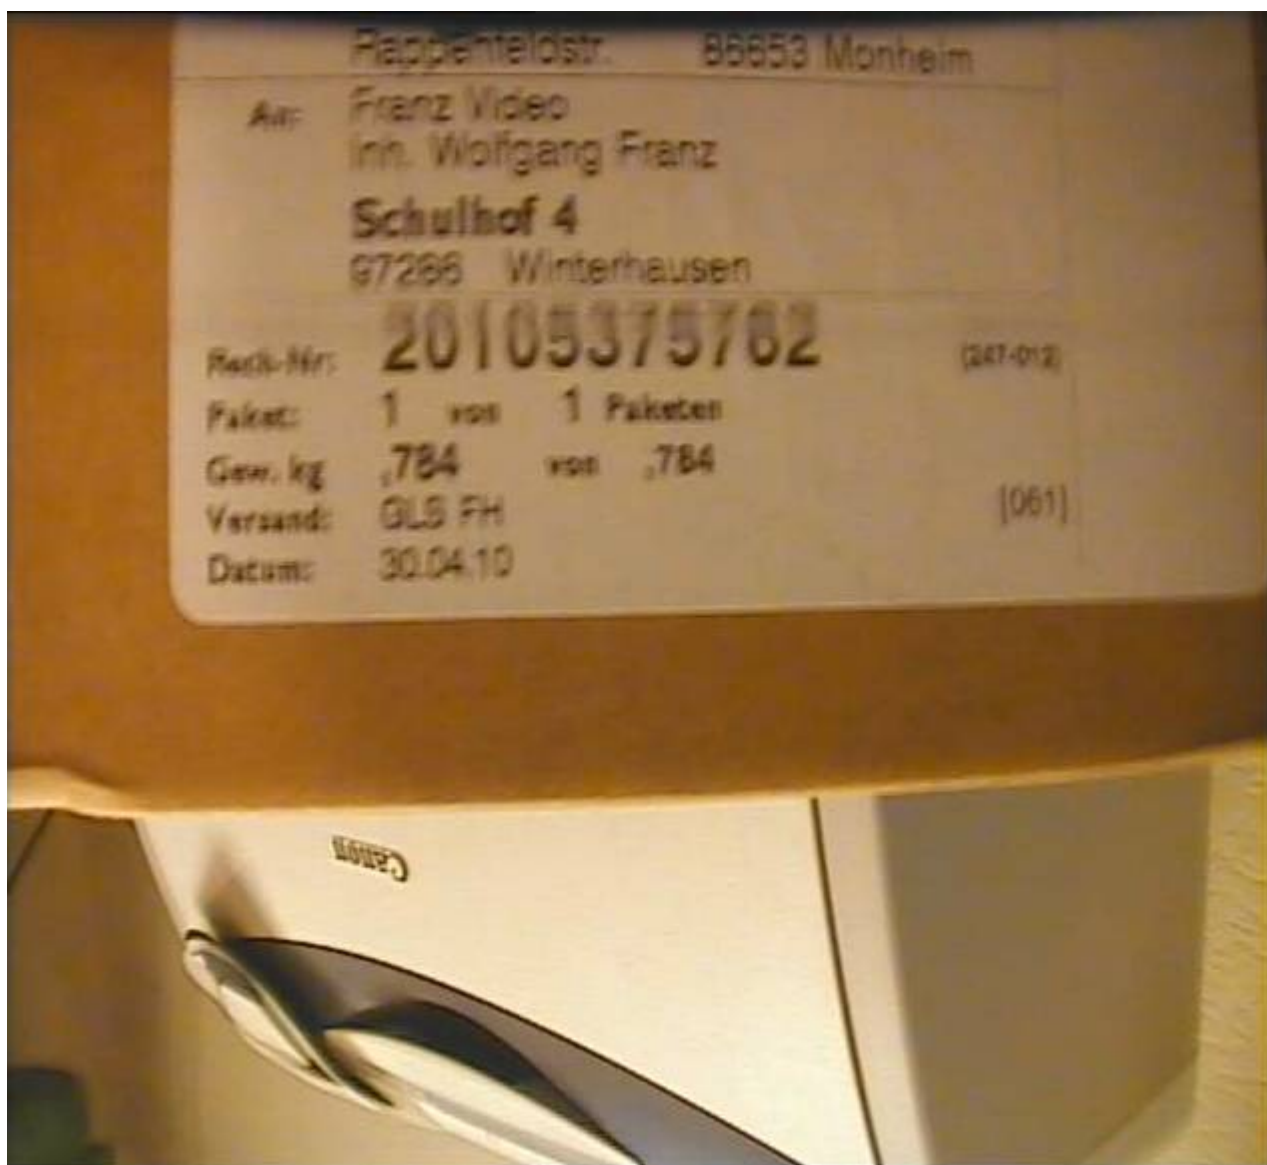
this picture are taken with original glas , so you can see the unsharp area.

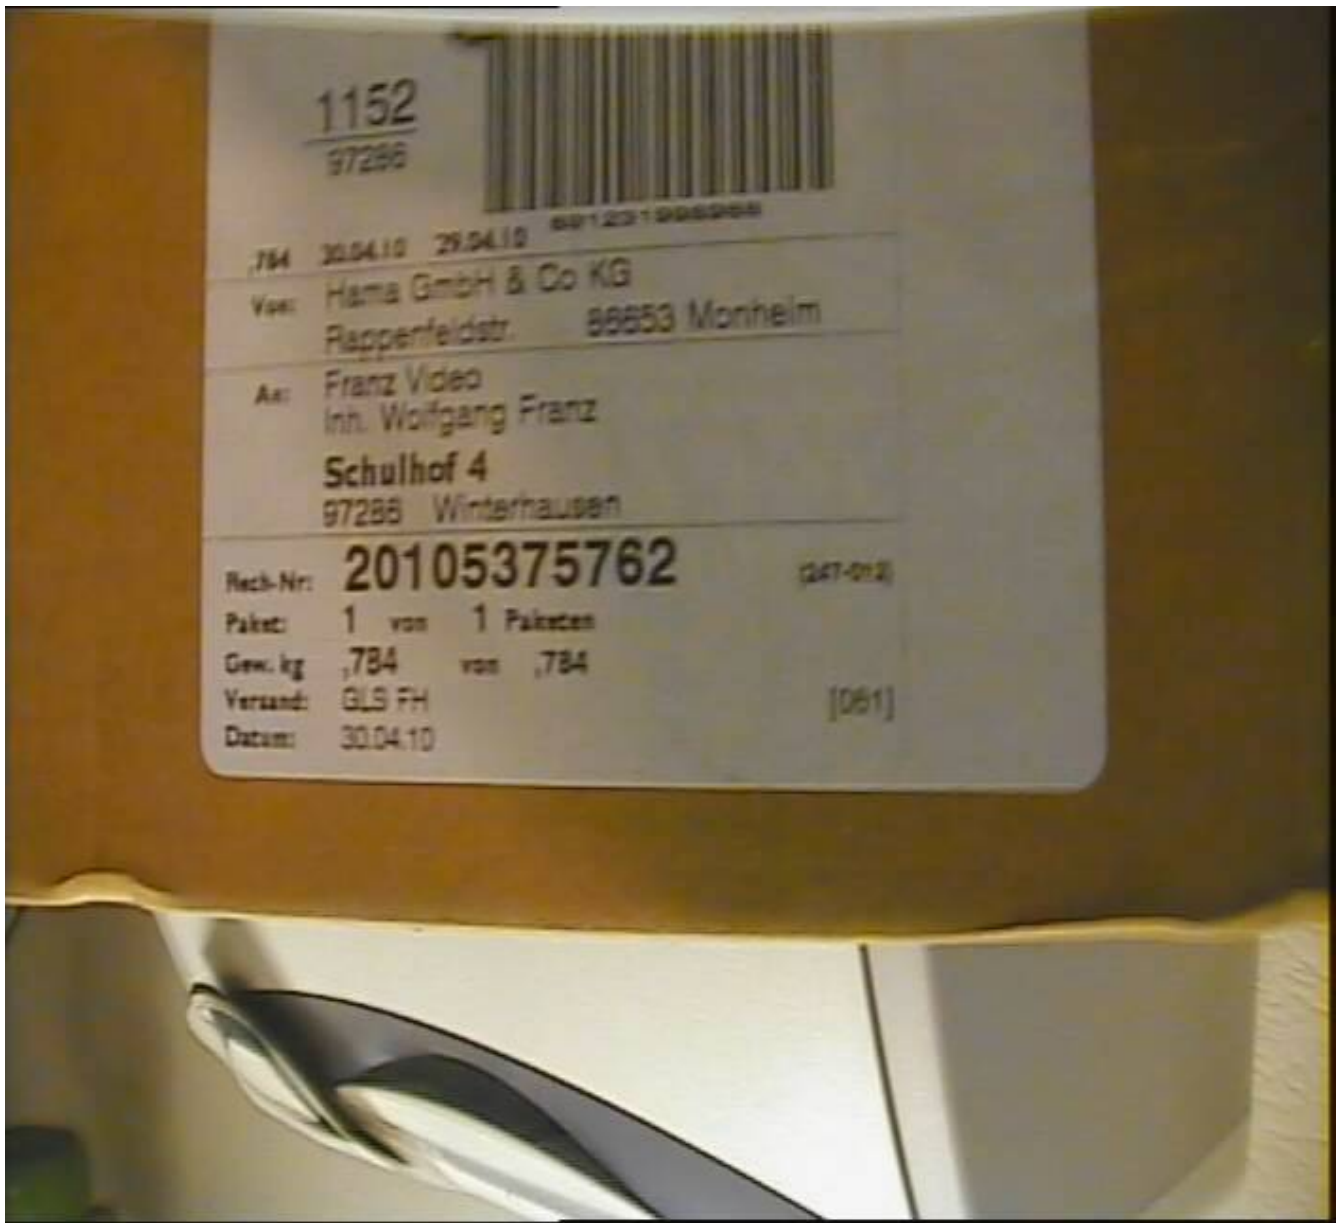
same picture with our replacement glass, now you can read the Pack.Nr.clearly

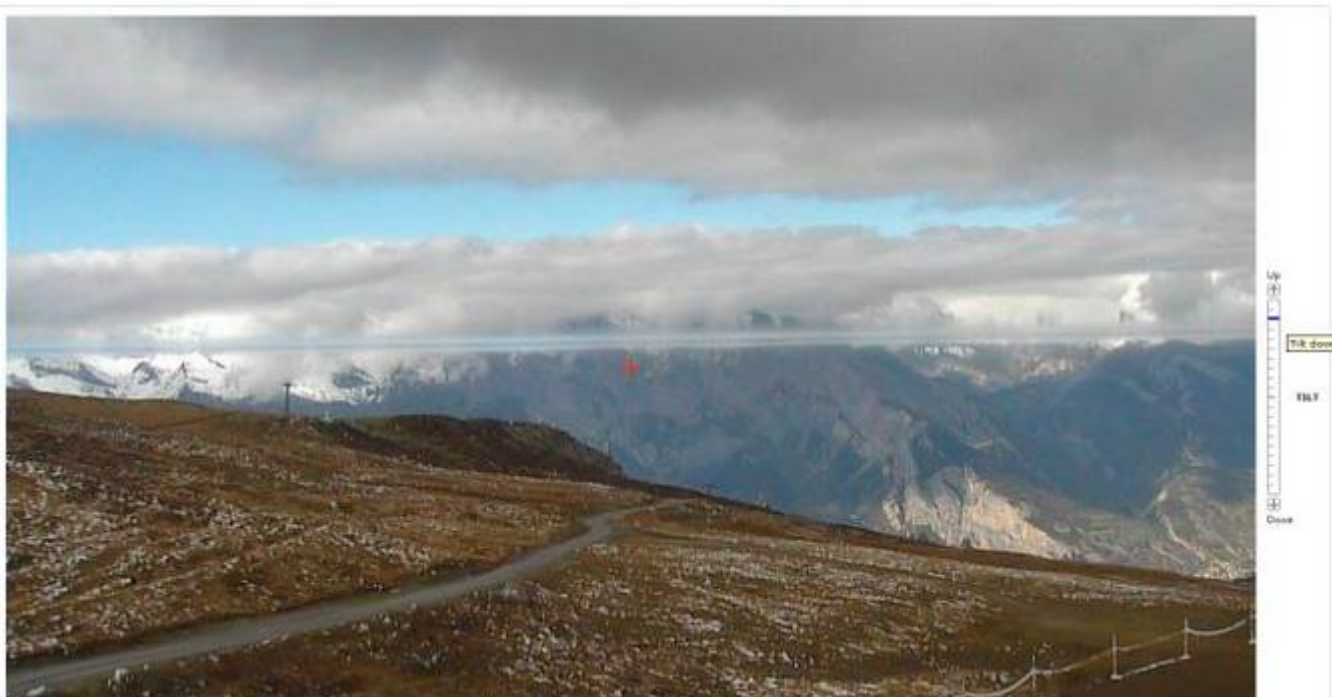
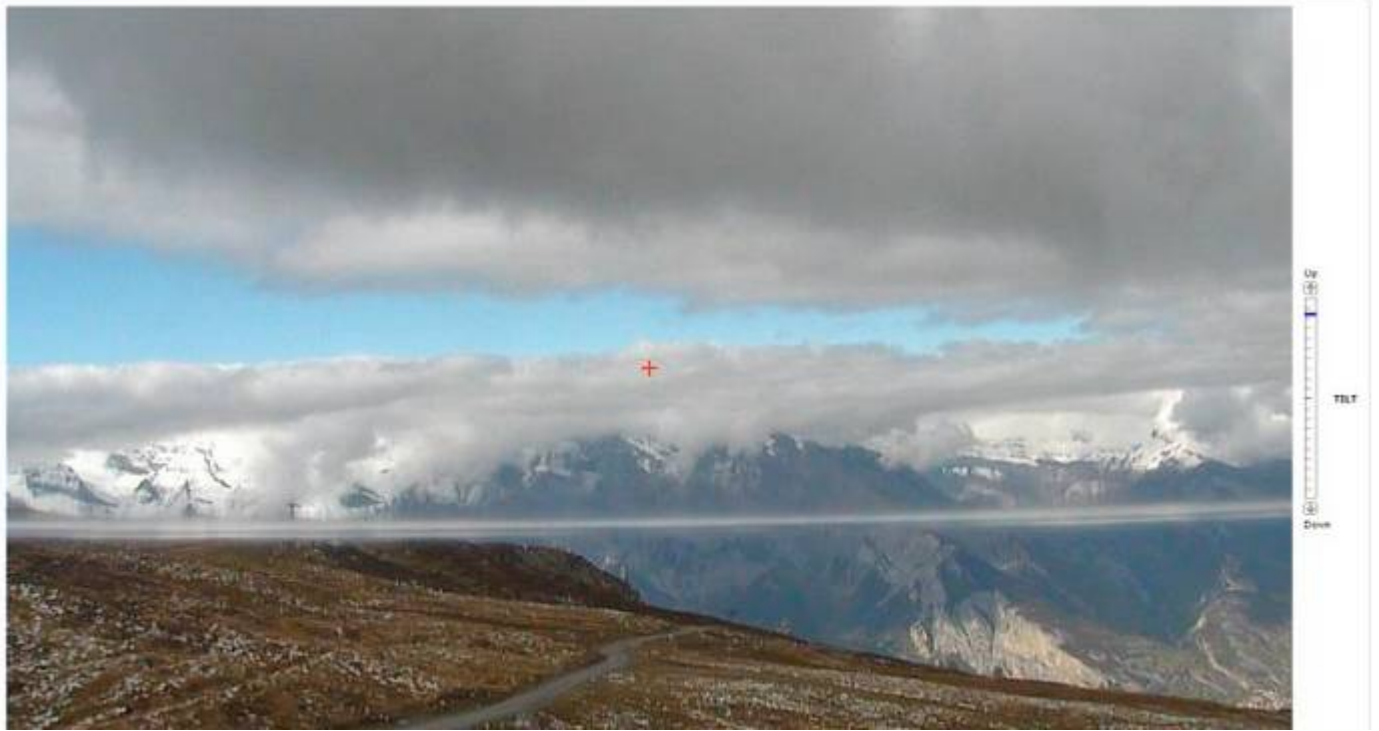
Above livepictures from original cameraglas AXIS Q6034

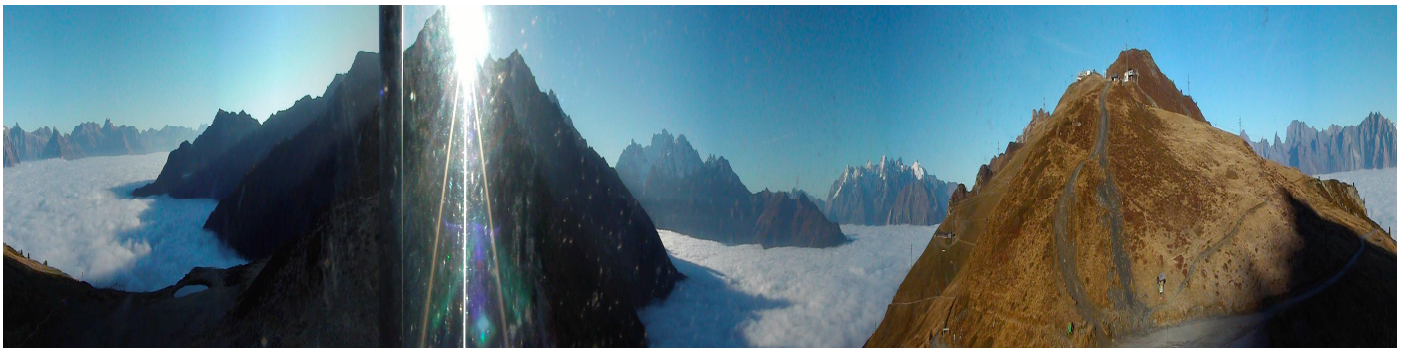
with Adapterglas

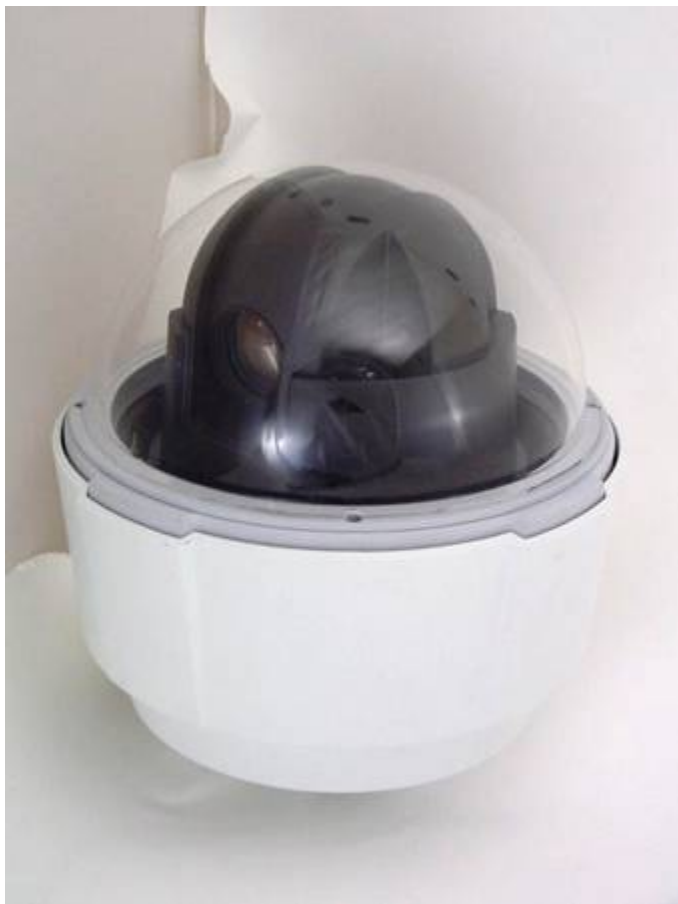
6032 with new glas,
